Refurbishing Your HF Antenna

By Marinus A. Willemstijn ZS6MAW

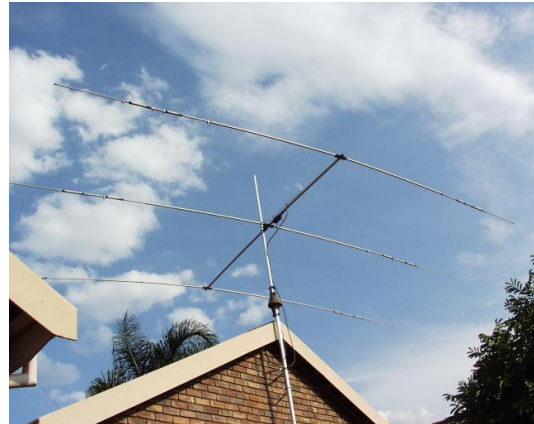
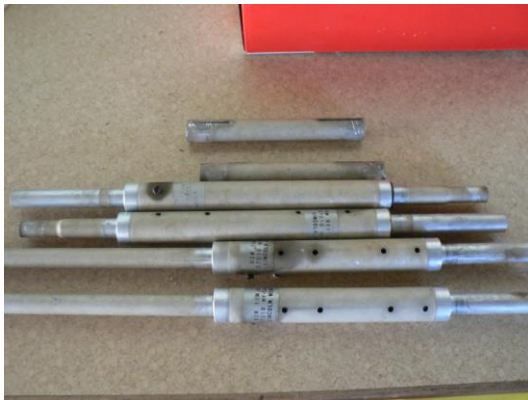
The photographs show the TH3JR and CD45MKII in its last position before it was taken down.

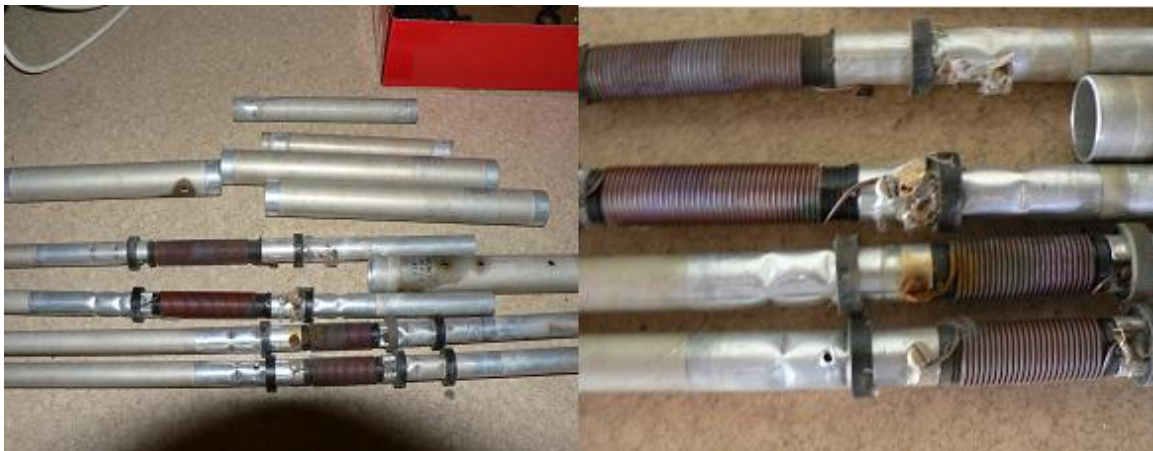
I dismantled the different pieces of the antenna and removed all plastics on the antenna. Part of the dismantling process was opening the traps of the antenna (There are 12 traps on the TH3JR). The traps were each very carefully checked. There

was definite evidence of water corrosion in some of the traps. I used a soft toothbrush with clean water to remove the grit off the windings. Some of the screws used to connect the copper wire of the winding to the aluminum tubing were also corroded. The screws holding down the aluminum trap covers had started to corrode as well and will thus be replaced.

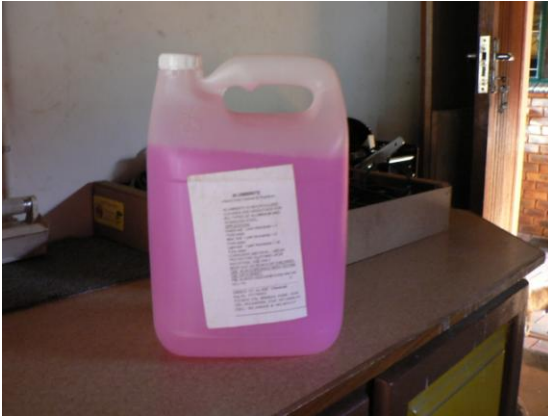
I purchased a cleaning solution called Alumibrite. This chemical was specifically developed to clean aluminum. It is an industrial type chemical that needs to be handled with great care. I used rubber gloves during preparation of the solution and also during the cleaning of the antenna. I prepared the solution in an old bucket with a wider throat than a normal bucket for ease of working. By changing the ratio of Alumibrite to water one can change the aggressiveness of the cleaning agent. I opted for the 9:1 water to chemical ratio which is considered to be a medium strength as per the instructions. I had another bucket with clean water to immediately rinse the aluminum after cleaning. In hindsight I could have saved lots of time and effort had I used a longer type basin where the lengths of aluminum could be totally submerged in the solution. Naturally the same applies for the rinsing process. Using Alumibrite is really very easy. I used a soft cloth to gently apply the cleaning solution to the surface of the aluminum, then rinsing the solution off with clean water. All the dirt seemed to pop right off!

The great thing about this solution is that it did not affect any of the non aluminum components of the antenna. For instance the printing of the labels of the traps were 100% in tact after the cleaning the antenna. Later on I used a drop of Turpentine later on to clean a small paint spot from the boom and it immediately also removed some of the printing on the labels which was "spared" by the cleaning solution. Although I dried the aluminum with a soft cloth after rinsing, I allowed it to drip dry for a day or two.

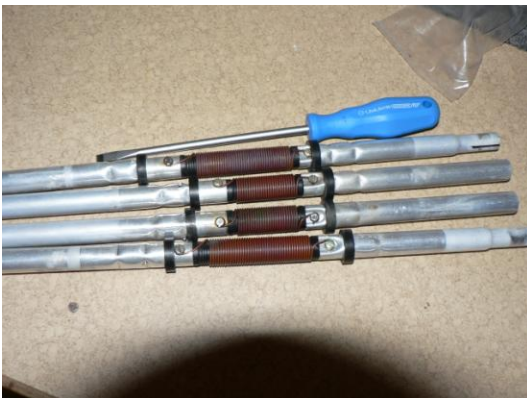
I did not submerge the traps into the solution as I was not sure whether it would affect the copper wire. It would probably be better to totally disassemble the plastic portion of the trap from

the aluminum parts to enable easier cleaning but I did not believe it was worth the effort (Especially as I only needed to replace a couple of screws inside the traps).

I cleaned all the brackets with normal soap and water which restored them to an almost original condition.

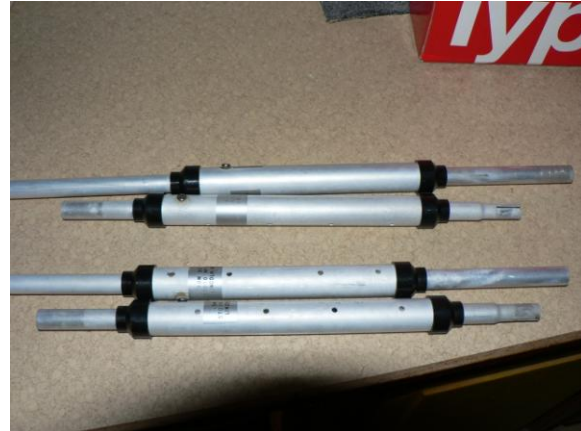
Replacing the Plastic Caps is much easier than getting hold of them. It is however extremely convenient having all the plastic components in one package. I found a reasonable comprehensive kit specifically made for this task supplied by Hy-Gain on their web site. It's called PK-TH3JR-PLS. Place your order for the kit well in advance as it takes at least 1 month to import. The plastic rings that can be seen on both sides of the open traps shown in the picture are not included in the plastics kit. I inspected all the rings and found that they were all as good as new – They are covered by the trap housing

and unless they got lost, I cannot see you having to replace them. It would however have been a nice touch had Hy-Gain included a few of these rings in the kit in case some had to be replaced.

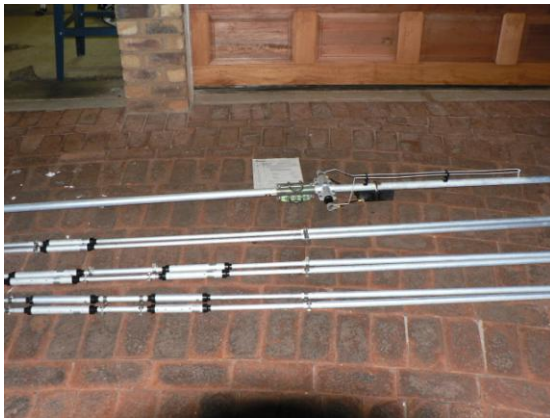
Once all the pieces were cleaned, rinsed, dried and re-assembled the beam was reassembled. It's important to ensure that the traps are clearly marked to enable you to easily identify the different traps as they are not all equal in size. Despite the fact that the markings of the original measurements were still visible I decided to re-do all the measurements from scratch using the Instruction Manual.

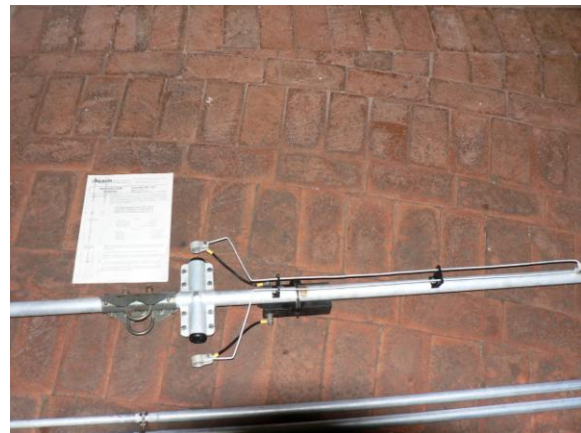
Final assembly and testing is done in the back yard on a small 3M tower. A MFJ 269 HF/VHF/UHF Antenna/SWR/RF Analyzer was used to check that the SWR on all bands were acceptable.
